Instability of slopes along the Nymphopetra to Strymonas section of the Egnatia Highway in N Greece

MARIA CHATZIANGELOU¹ & BASILE CHRISTARAS²

Abstract: The Nymphopetra to Strymonas section of the Engatia Highway is about 60km long, and is located in northern Greece, to the North-East of Thessaloniki. It is divided into two parts: i) Nymphopetra-Asprovalta, about 40km long and ii) Asprovalta-Strymonas, about 20km long. The Asprovalta-Strymonas section has already been constructed while the Nymphopetra-Asprovalta section is under construction.

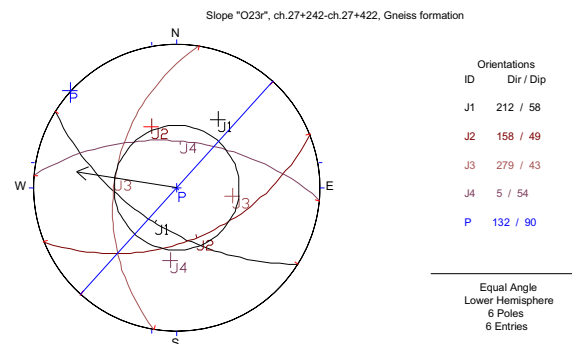
According to stability analysis of the “O23₁” slope, the type of probable sliding is; i) a planar sliding of gneiss rock mass along the joints directed to 279/43 and ii) a potential wedge sliding at west direction. The planes of joints 212/58 and 279/43 form the wedge (Figure 7). The marble rock mass may slide along the joints of 287/71. As the rock mass is slightly weathered, there is no possibility of circled sliding (Figure 8).

Figure 7. Major discontinuities' planes at slope “O23_r”(gneiss)

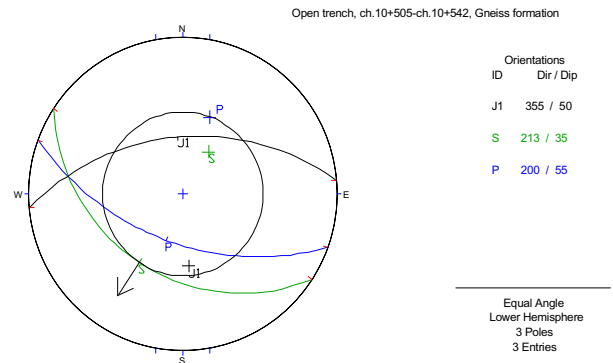
Taking into account that the friction angle of the rock mass is about 35°, gneiss formation, being placed between ch.10+505 and ch.10+556 of the third bench of the open trench, may slide along the direction of schistosity 213/35 (Figure 11, Figure 12). The same formation, being placed between ch.10+510 and ch.10+520 of the 2nd bench, may slide along the direction of schistosity 246/42 (Figure 13). There is a part of completely weathered gneiss, being placed between ch.10+670 and ch.10+680 of the 2nd bench, which may slide along the direction of the section being formed by schistosity 229/48 and joints 169/53 or 125/85 (Figure 15). Marble formation, being placed between ch.10+600 and ch.10+640 of the 2nd bench, may slide along the direction of the section being formed by schistosity 195/39 and joints 278/76 (Figure 14).

Figure 11. Major discontinuities' planes at the open trench between ch.10+505 and ch.10+542

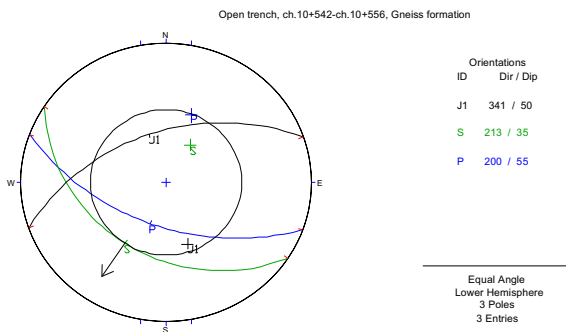
Figure 12. Major discontinuities' planes at the open trench between ch.10+542 and ch.10+556

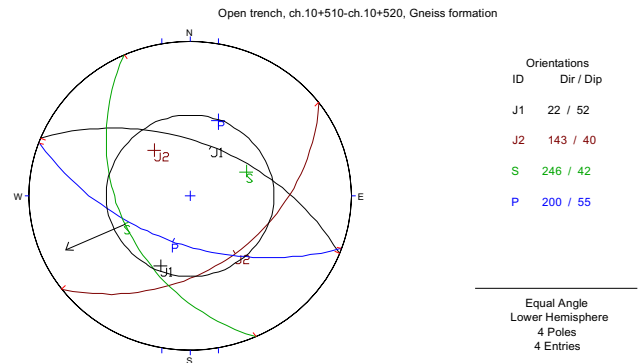
Figure 13. Major discontinuities' planes at the open trench between ch.10+510 and ch.10+520

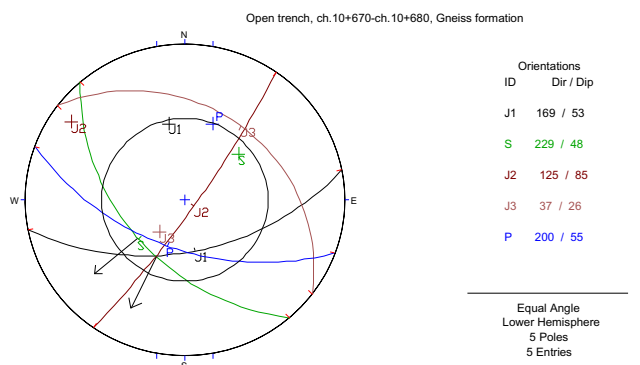
Figure 15. Major discontinuities' planes at the open trench between

between ch.10+600 and ch.10+640

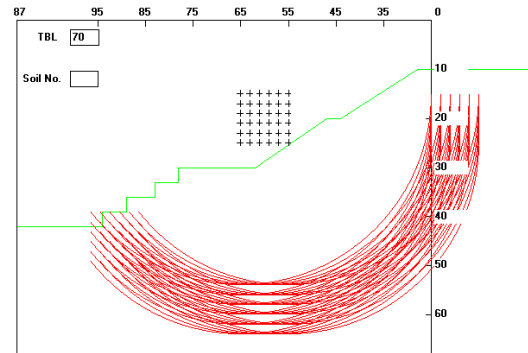
The lake deposits on “O11” slope may slide along the direction of the bedding 162/39. Two potential wedges are formed by; i) bedding 162/39 and fault 255/46 and ii) joints 101/84 and bedding 162/39. The sliding takes place at SSW direction (Figure 4). Also, the critical slip circle was estimated using slope geometry of 15m high and slope inclination of 90°. The radius of the critical circle is estimated 15m and the safety factor for saturated conditions is calculated 3 (Figure 16).

X Cen	Y Cen	Radius	Slices	Safety Fac
5,00	10,00	15,00	15	3,00

Figure 16. Critical slip circle and safety factor of slope "O11", in saturated conditions

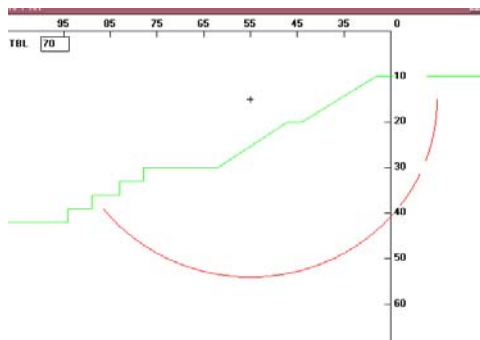
Figure 17. Circle sliding analysis and safety factor of slope "O19" before the embankment's construction, in unsaturated conditions

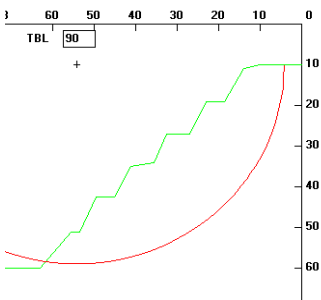
X Cen	Y Cen	Radius	Slices	Safety Fac
25,00	10,00	50,00	80	7,00

Figure 22. Critical slip circle and safety factor of slope at “ch.9+700” using the begging geometry in unsaturated conditions

Terraces inclined at 45° are proposed to form the “O22” slope in order to be protected from planar sliding. The maximum height of the slope is about 50m. Taking into account that the slope consists of absolutely weathered gneiss ($\gamma=2,65\text{gr/cm}^3$, $\phi=26^\circ$, $c=0$), there is a potential cycled sliding. But according to slope stability analysis in saturated conditions, the slope is stable as the calculated safety factor of the critic circle is 7 (Figure 21).

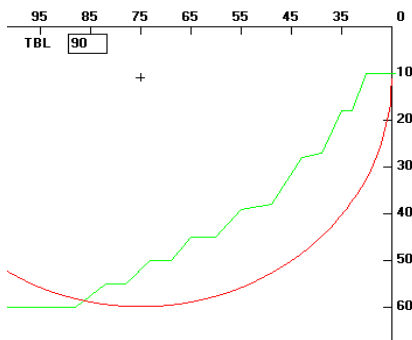
Figure 24. Circle sliding analysis of slope "O11" using the proposed geometry in saturated conditions. Critical circle;(x,y):(5,5)

In order to protect the slope "O11" against sliding, a slope inclination of 34° is proposed. Using the proposed inclination, the radius of the critical circle is estimated at 29m and the safety factor is calculated 5 in saturated conditions (Figure 24).

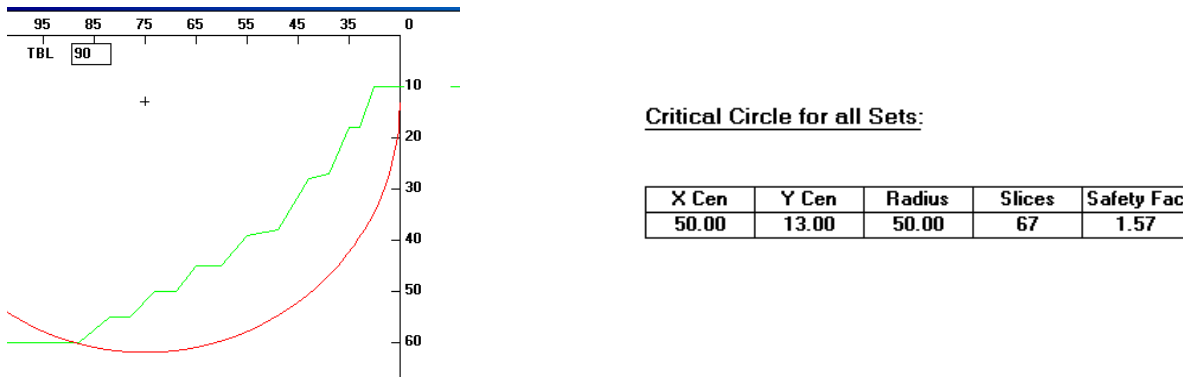
X Cen	Y Cen	Radius	Slices	Safety Fac
50.00	11.00	50.00	62	2.08

Figure 25. Critical slip circle and safety factor of slope at "ch.9+700" using the proposed geometry in unsaturated conditions
