Safety assessment and land planning development of abandoned quarries in urban areas – A case study from the city of Athens, Greece

CONSTANTINOS LOUPASAKIS¹ & JOHN KARFAKIS²

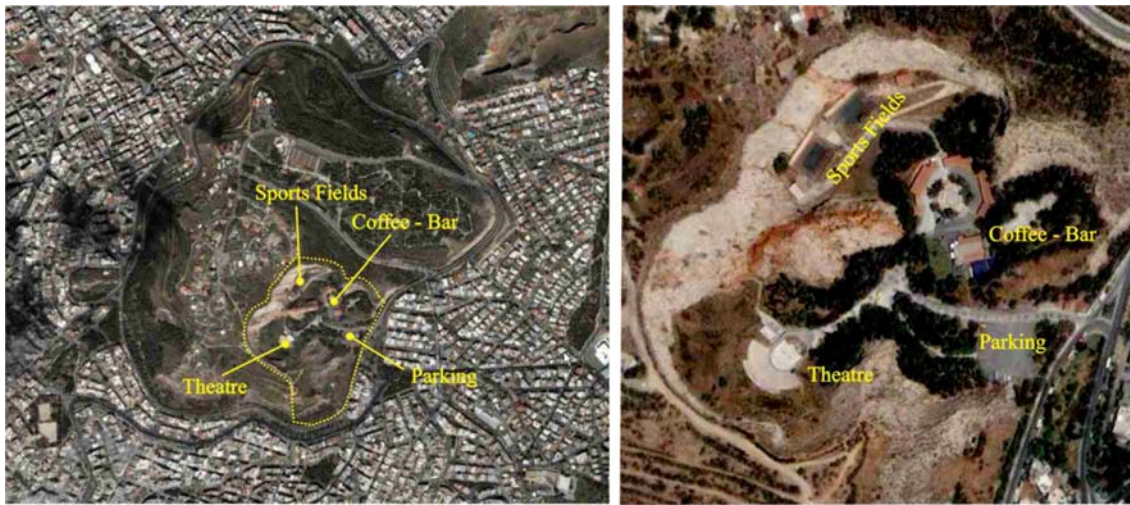
Figure 1. Aerial photographs of the Turkovounia hill (left) and of the “Attiko Alsos” park (right). The boundaries of the quarry are marked by the yellow dotted line. The quarry occupies an area of 200.000 sq.m. (about 50 acres).

As presented in Figure 1, the quarry was big enough to allow multiple land planning design. Most of the described proposed measures could be reduced, if during the land planning design of the site the engineering geological data had been taken into consideration. If the theatre and the athletic facilities were constructed a few meters away from the base of the slopes most of the protective measures would become redundant.

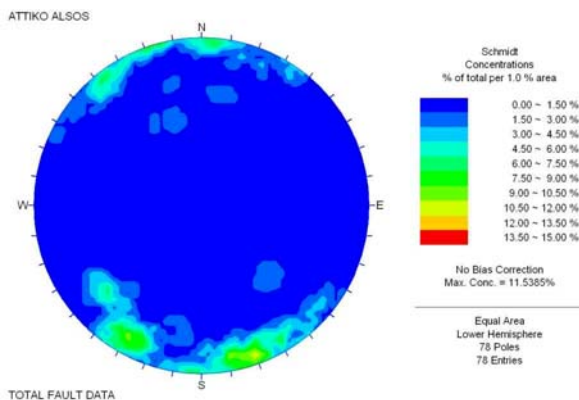
During the engineering geological mapping of the quarry, thirty one (31) normal faults were located. The projection of the tectonic data on the Schmidt net reveals that the orientation of their main attitude is E-W (Figure 2). This means that the main tensile stress field orientation is N-S.

Figure 2. Stereographic projection of the faults’ data.

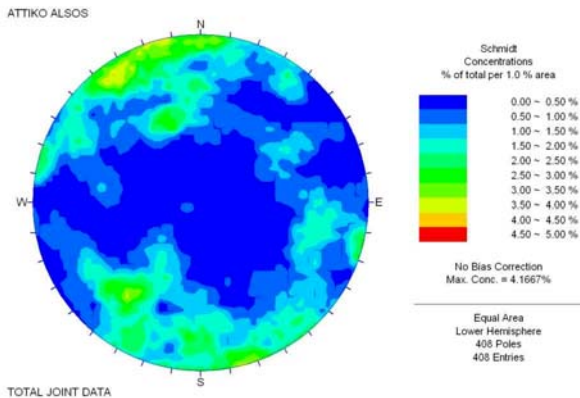
Evaluation of the tectonic data collected from the joints, revealed that numerous joint sets are not related to the major tectonic structure’s stress field. As presented in Figure 6, the statistical evaluation of the tectonic data shows ten (10) joint sets. Most of them appear locally distributed. It seems some of the local discontinuities were affected, besides the stress field, by the excavation procedure. The blasting of the rock mass, without using any pre-splitting techniques, reveal discontinuities are affected mostly by the anisotropy and the lack of homogeneity of the rock mass and secondarily by the stress field. This conclusion is supported by the fact that all the locally distributed discontinuities appear very small length (10-20 cm), exhibit random spacing, no separation and show no evidence of karstic weathering.

Figure 6. Stereographic projection of the joints data.
