# The study of rainfall induced sliding of a fill slope in Shenzhen, China

**Abstract:** Due to over 200 millimetres of heavy rainfall on 19 August 2005 and over 300 millimetres of heavy rainfall on 20 August 2005 in Shenzhen, a fill slope was found to be sliding with an approximate volume of 150,000 cubic metres of material involved. A lot of cracks were produced during the two days. The accumulated horizontal deformation along the whole fill slope was up to 500 mm.

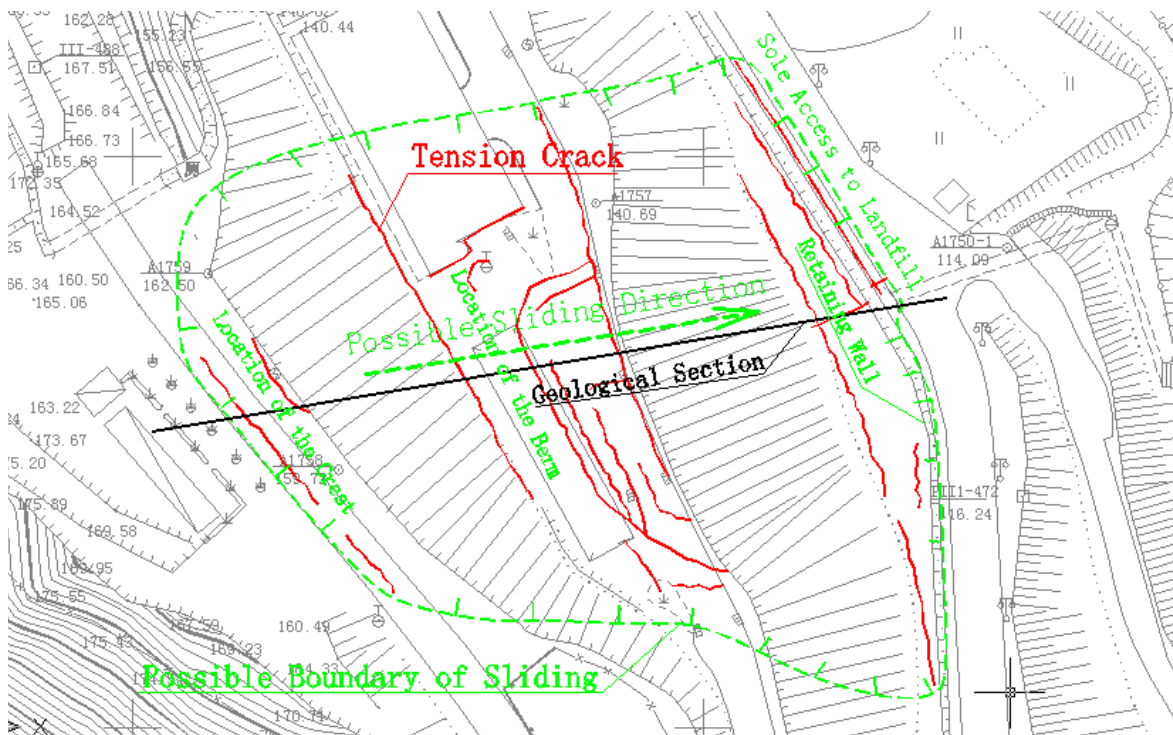
Figure 1. Plan of possible sliding boundary of the fill slope

Once the rainfall stopped on 21 August 2005, ground investigation within the possible boundary of sliding (Figure 1) was carried out at the fill slope site. The final factual report of ground investigation was completed in October 2005. Ground investigation works include topographical survey, drillholes, trial pits, geophysical exploration, insitu testing, laboratory testing and field monitoring of groundwater and horizontal deformation. A total of 53 drillholes were formed at the fill slope site.

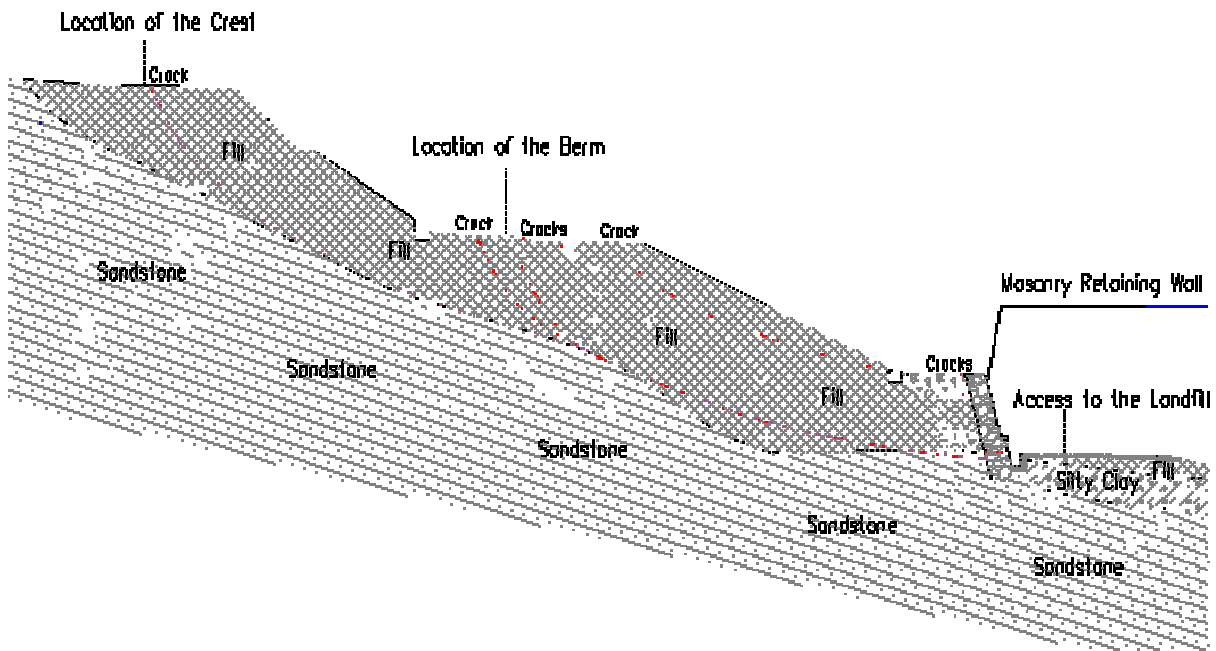
**Figure 2.** Typical geological section of the sliding fill slope

The geology of the fill slope, as revealed by the ground investigation, consists of mainly fill, which is underlain by highly decomposed sandstone (Figure 2). The fill is mainly made of highly decomposed sandstone with some silty clay in some locations. The maximum depth of the fill slope is up to 17 m.

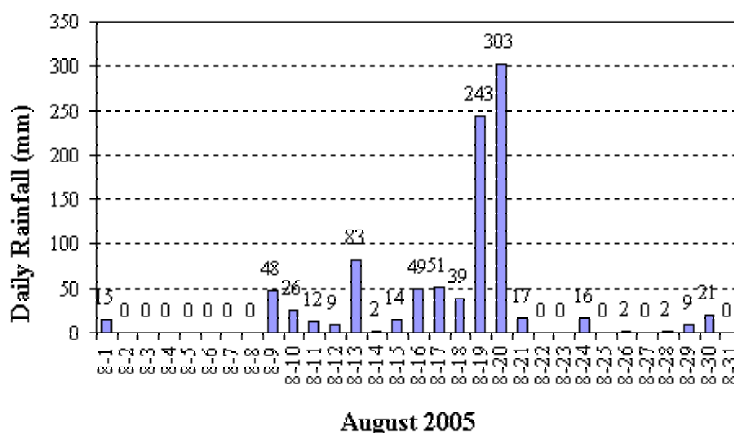
**Figure 11.** Daily rainfall in August 2005

The climate in Shenzhen is sub-tropical and monsoonal, with mild, dry winters and hot, humid summers. Furthermore, heavy rainfall is very common in Shenzhen and is usually associated with slow-moving troughs of low pressure and tropical cyclones. The daily rainfalls recorded by Shenzhen Observatory Bureau in August and September 2005 are shown in Figures 11 and 12, respectively. From Figure 11, we know that the rainfall on 19 August 2005 is 243 mm and the rainfall on 20 August 2005 is 303 mm, although the rainfall on the preceding day of 19 August 2005 was not particularly high. From Figure 12, we know that the rainfall on 25 September 2005 is 130 mm, which was brought by Typhoon Damrey.
