# Engineering geological and geotechnical aspects of the Soufriere Hills volcanic eruption, Montserrat

**Abstract:** The Soufrière Hills volcano on the British dependant Caribbean island of Montserrat began to erupt in July 1995, after about 400 years of remaining dormant. Phreatomagmatic explosions were followed by the extrusion of an andesitic lava dome within English crater. Its periodic collapse resulted in the generation of pyroclastic and explosive events, from 1996 onwards. Engineering geologists and geotechnical engineers have been involved in the various stages of the volcanic crises. These have included hazard identification, evaluation and zonation, risk assessments, monitoring, evacuation, exploration, redevelopment and construction. Various ground deformation features were observed, monitored and investigated on the crater walls and expanding lava dome. These included rock falls, pyroclastic flows, explosions, lahars, landslides and distinct, steep-sided subsidence depressions. Secondary geological hazards were also investigated on the island, beyond the area of primary volcanic activity. These had a significant impact on transportation, utilities and residential area

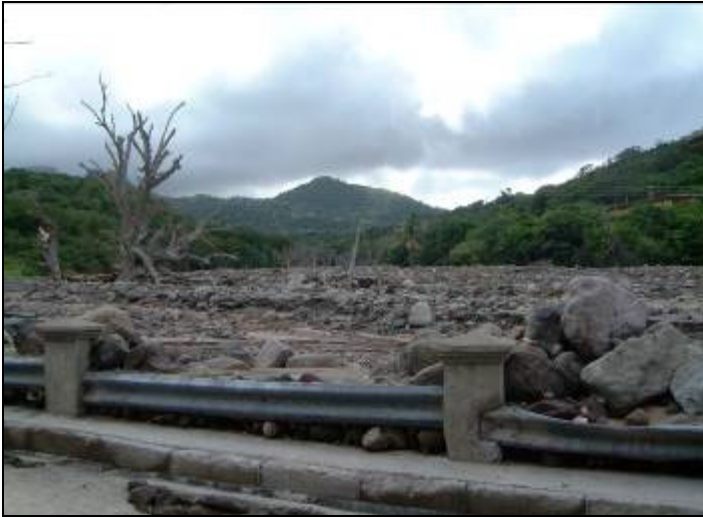
**Figure 5.** The Belham Valley Bridge with lahar deposits up to deck level. The lahar deposits consist of granular, variable, well-rounded, highly spherical, cobbles & boulders (mainly andesite and dacite) and sub-rounded, elongate cobbles and boulders with preferential alignment and cross laminations. The deposits were loosely packed, highly permeable, porous, saturated, with occasional clay and silt, some rootlets and tree stumps. The bridge deck currently lies at least 3.8 m below existing ground level.

A ground investigation and feasibility study was undertaken in the Belham Valley, in March 2005, for the design and construction of a replacement bridge. A qualitative assessment of the ease of excavation for the 30 trial pits gave some measure to the degree of consolidation for the deposits. The relative stability of the trial pit walls was recorded based on a qualitative classification, to give an indication of the relatively stability (Table 1). This table provides an initial assessment of the groundwater conditions, which influence the engineering behaviour and properties of the lahar deposits. This information may assist structural engineers to make an initial judgement to the type of possible foundations. These observations provide a useful indication of ground conditions and 'soil' types ahead of more detailed ground investigations. Engineering geological and geotechnical ground investigations, conducted in March 2005, shown the Belham Valley bridge currently lies under at least 3.8 m of 'recent' lahar sediments (Figure 5).

The lahar deposits consist of granular, variable, well-rounded, highly spherical, cobbles & boulders (mainly andesite and dacite) and sub-rounded, elongate cobbles and boulders with preferential alignment and cross laminations. The deposits were loosely packed, highly permeable, porous, saturated, with occasional clay and silt, some rootlets and tree stumps. Parts of the deposit consisted of a boulder-strewn field with individual boulders in exceeding of 3 m in diameter. In some of the trial pits palaeo-weathered surfaces, fossil soils and flow contacts of successive pyroclastic flow and lahar deposits were observed. These were characterised by red-brown weathered clay secondary minerals and an uneven flow stratigraphic interfaces. In other trial pits curvilinear, slickensided, orange-yellow and green clay smears were observed in the upper 2-3 m of pyroclastics. These were interpreted to represent slip surfaces caused by the landsliding and mass wasting of the weathered bedrock. These may reduce the strength of the rock mass and could have implications for the position and design of engineered foundations. In general the lahar deposits were weak, with low strength, low to negligible bearing capacity and probably incapable of carrying the loads necessary to support a bridge on spread foundations.

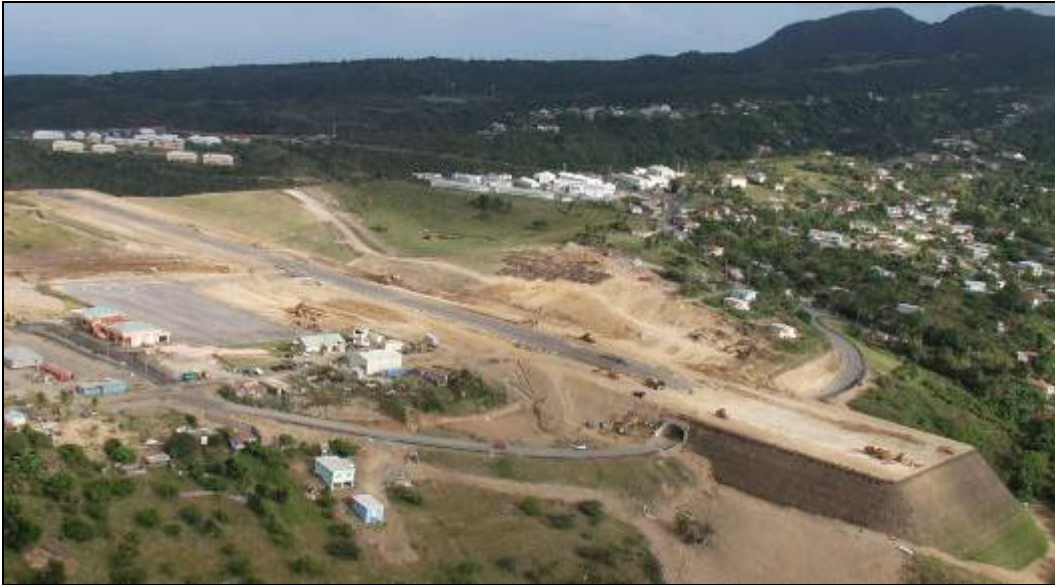
**Figure 6.** Photograph showing Gerald's Airport and the reinforced earth slope at the west end of the airport runway.

The new runway at Gerald's Park sits across a topographic ridge. The length of the runway required to allow the desired aircraft types to land was longer than the width of the ridge. It was therefore necessary to extend to the runway at each end, notably the west end. Due to the steep sides of the ridge any embankment constructed, effectively ended up chasing the natural slope downwards. Steep reinforced walls, gabion walls and reinforced embankments were considered. The preferred solution was to construct a 45° reinforced slope embankment. Due to the additional length of runway required the steeply dipping ground surface the vertical height of the embankment was some 30 m. The design of the embankment had to include seismic acceleration and required significant lengths and reduced spacing of the geotextile reinforcement. One problem encountered with the tuffs used the embankments was their high susceptibility to erosion during heavy rainfall and measures were necessary to protect the slopes which included the re-establishment of topsoil and native vetiver grass, *Vetiveria zizanoides* (Figure 6).

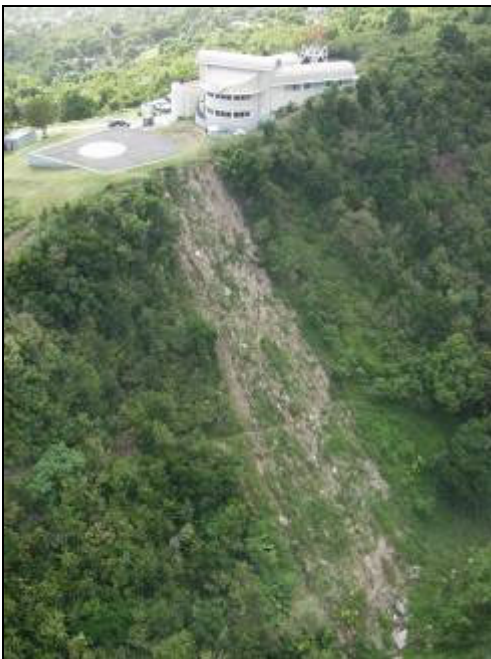
**Figure 7.** The Montserrat Volcano Observatory landslide; a complex debris slide earthflow with a component of rotational slip (source: Montserrat Volcano Observatory & British Geological Survey).

Landslide events on Montserrat have been overshadowed by the more spectacular, destructive and widespread damage associated with the eruption of the Soufrière Hills volcano. There is however, evidence for past and recent landslides through the Caribbean including Montserrat (Degraff *et al.* 1989). Exposed roadside rock, soil and debris cuttings are particularly susceptible to ravelling, sheet wash and gulying during rainfall or after tropical storms and hurricanes (for example several landslides were induced in 1989 when Montserrat was hit by Hurricane Hugo). Steeply dipping and vertical slopes appear to be less affected than more gently inclined cuttings that allow the accumulation and drainage of rainwater. Landslides, instability, subsidence and ground deformation were observed on Gages Wall, the flanks of the English Crater and around geothermal springs (known as soufrières) (Figure 7).

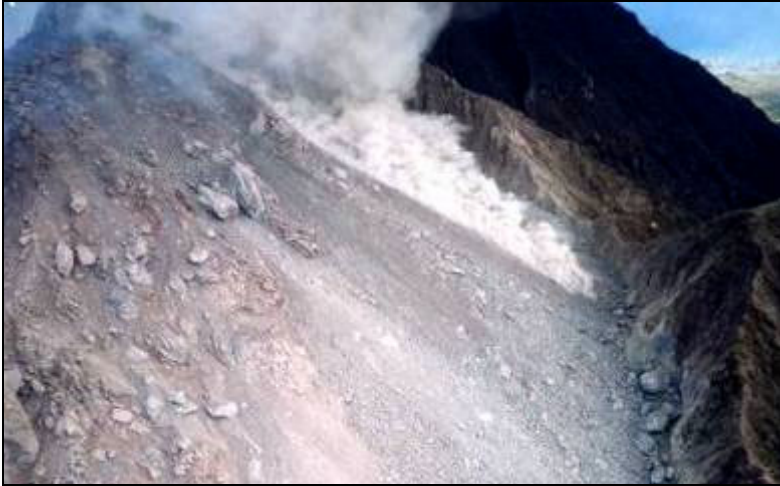
**Figure 8.** Failure of the flanks of the expanding lava dome and extrusive ‘spines’ generating a series of rock falls, topples, slides and flows. Instability is influenced by the density, geometry and type of rock mass discontinuities in the dome.

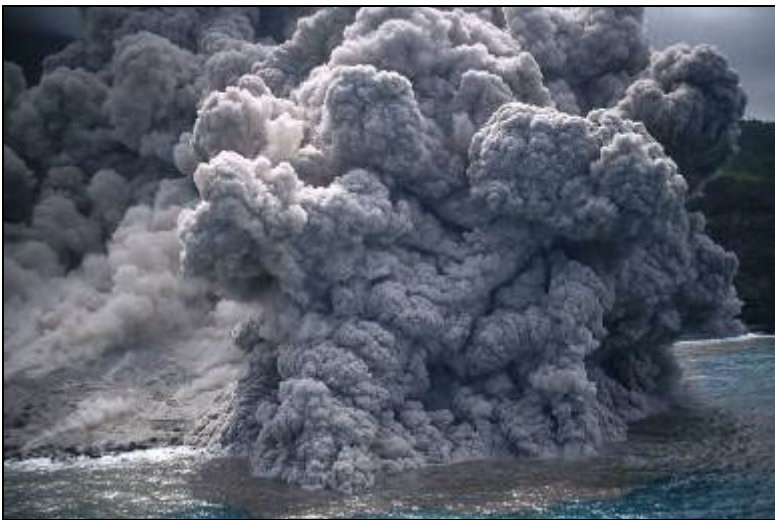
**Figure 9.** Large rocks falls and rock avalanches may develop into dome collapse pyroclastic flows. These tend to be controlled by topography, flowing along valleys (ghauts). Some pyroclastic flows have sufficient energy to reach the ocean (source: Montserrat Volcano Observatory & British Geological Survey).

Rock falls, rock avalanches, debris slides and debris flows on the lava dome have been generated during the extrusion and growth of lava domes (facilitated by the escape of rapidly expanding volcanic gases), followed by gravitational collapse and the generation of pyroclastic surges, (accompanied by ash clouds and explosions) (Figure 8). Dome collapse pyroclastic flows were first observed, to travel from the volcano into the ocean, in 1996 (Donnelly 1996b). Since then numerous pyroclastic flows have been observed and documented (Calder *et al.* 2002) (Figure 9).
