Determination of the durability of some Egyptian monument stones using digital image analysis

ABOUSHOOK, M.¹, PARK, HD.², GOUDA, M.³, MAZEN, O.⁴ & EL-SOHBY, M.⁵

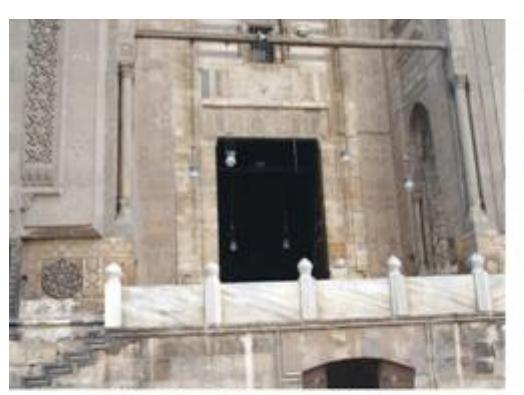
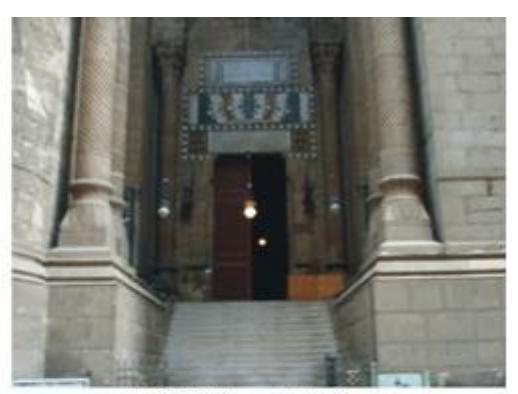
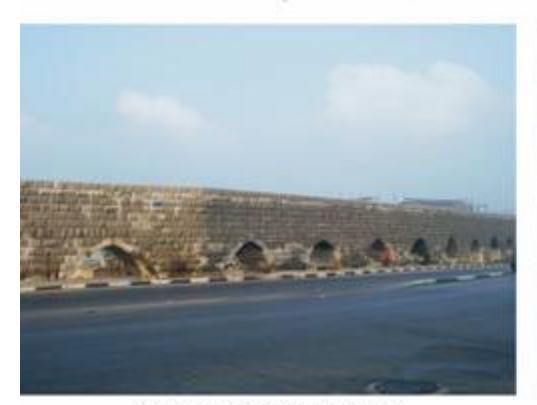
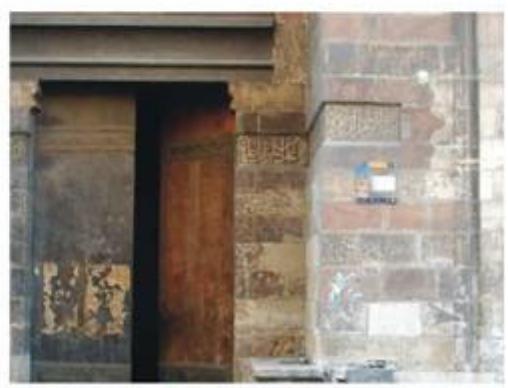
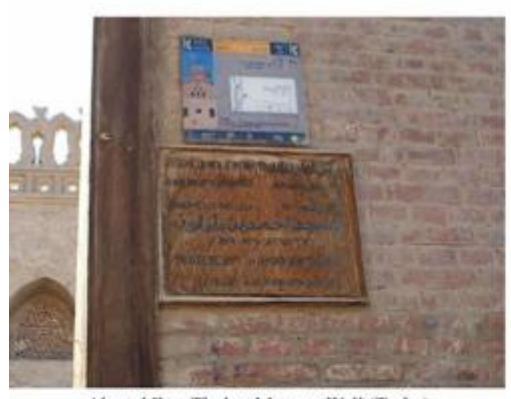
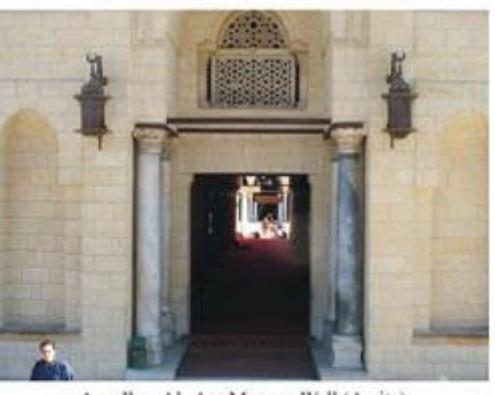
Sultan Hassan Mosque Wall (H-site)

Al-Rafaie Mosque Wall (R-site)

Magra El- Oyoon Wall (M-site)

Shikhone Mosque Wall (S-site)

Ahmed Ibn- Thulun Mosque Wall (T-site)

Amr Ibn- Al- Ass Mosque Wall (A-site)

- General images taken of the monument walls showing the entrance and wall stones (Plate 1).
- Images taken of stone decay seen in the monument walls showing different degrees of deterioration (light, medium, high) by the use of a digital camera (not less than 3 megapixels resolution) indicating the standard colors reference for each site (Plate 2).

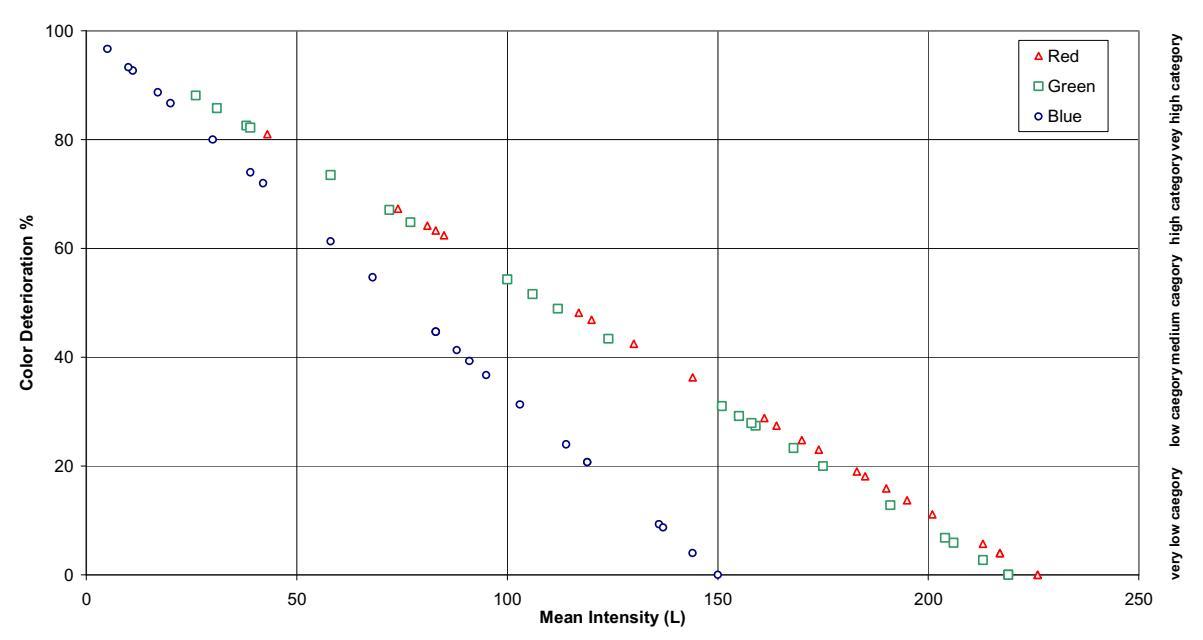
Figure 1. A classified chart to calculate number of effected color points for each proposed deterioration category (H sites)

- Figure 1 integrates all deterioration color values in one table for each monument site.
- The ordinate of the integrated figure which represent degree of Color Deterioration is divided into five categories as follows:

- Very low deterioration (zero to 20%)
 - Low deterioration (21 to 40 %)
 - Medium deterioration (41 to 60 %)
 - High deterioration (61 to 80 %)
 - Very high deterioration (81 to 100 %)

- All Color Deterioration points for each category of the five categories indicated were calculated. Consequently, the percentage in each category was known.

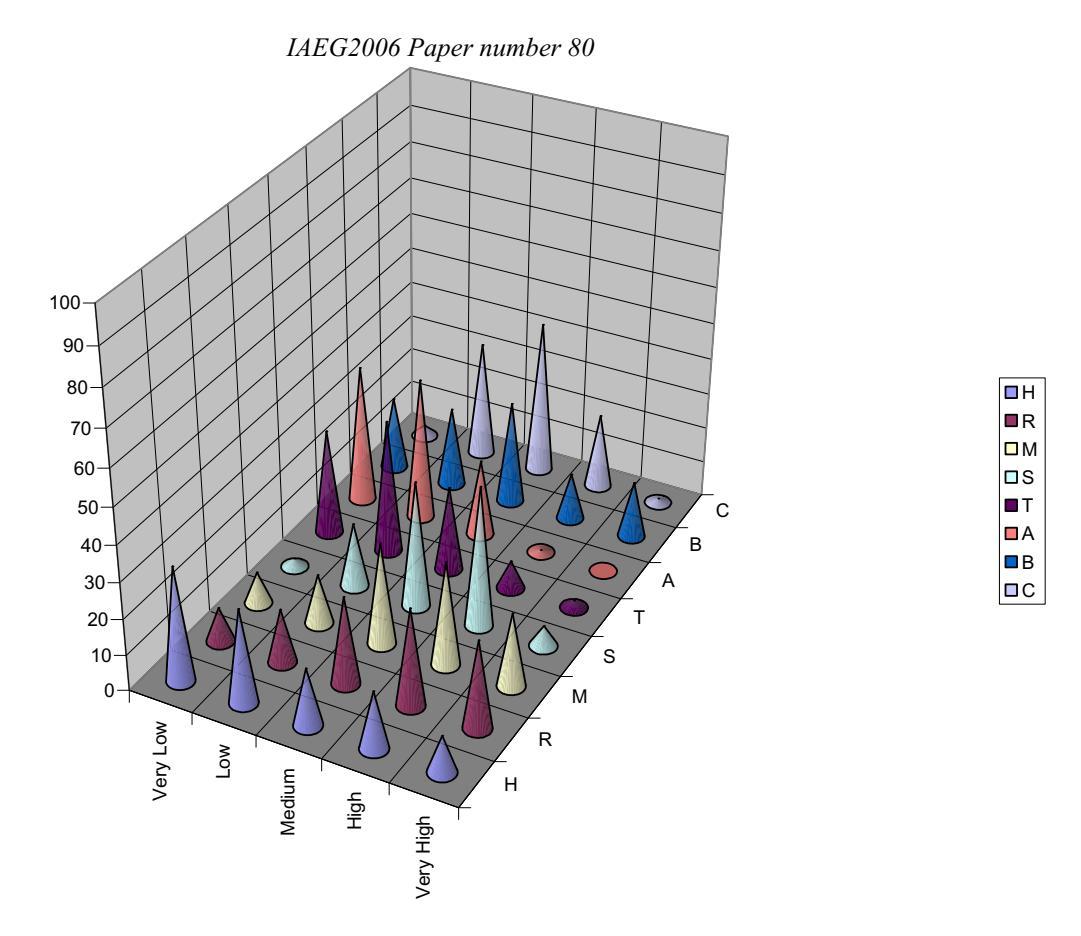
Figure 2. A representative chart for the proposed deterioration categories occuring in the studied monument stones. (Sites: H; R; M; S; T; A; B; C)

- General conditions of deterioration of the monument stones at the eight studied sites are presented in Figure 2.
